Revision
06/28/11

2RZ/3RZ Teflon Throttle Body Gasket (Part #1032099)

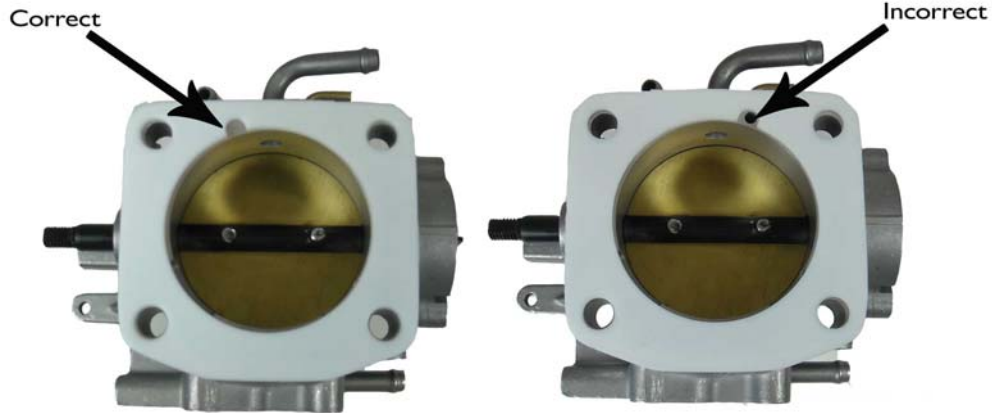
On the Teflon throttle body gasket there is a small notch cut out of the center hole of the gasket. This notch must be installed as shown below. Failure to install it properly will result in running issues.

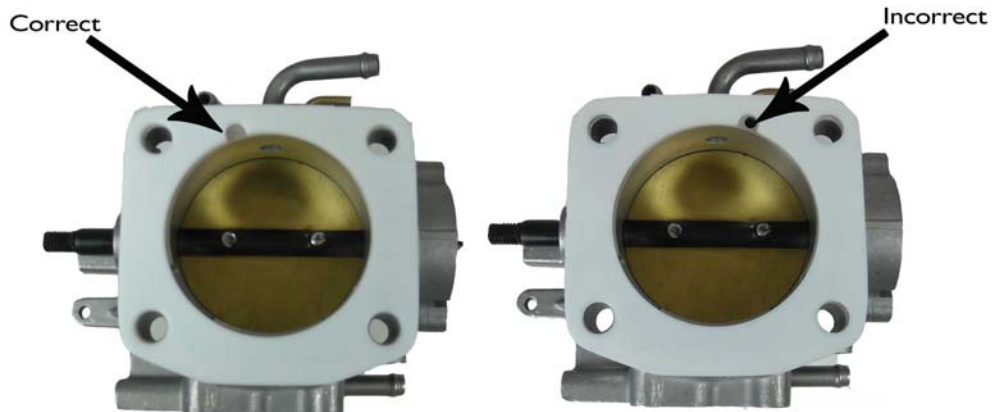
On the Teflon throttle body gasket there is a small notch cut out of the center hole of the gasket. This notch must be installed as shown below. Failure to install it properly will result in running issues.
