# CHECKING COMPRESSION RING GAPS (HASTINGS STREET PISTON RINGS)

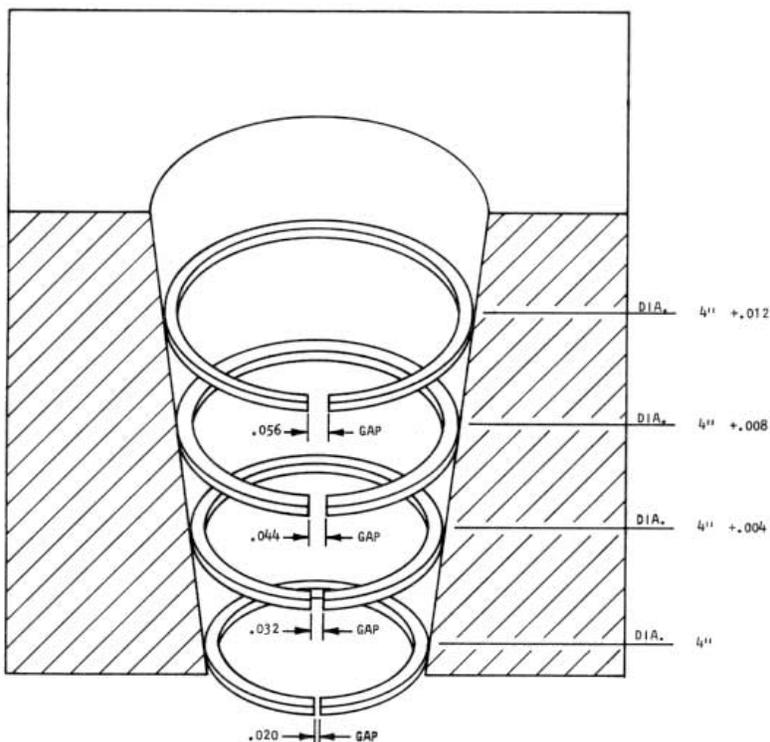
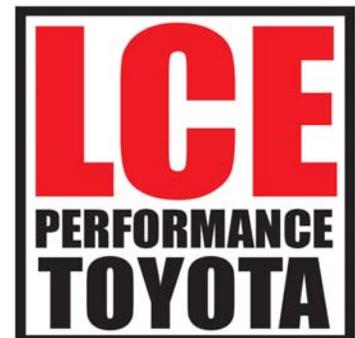
This graphically illustrates the effect on ring gap that cylinder wear has. You will notice that the tapered cylinder has .012" wear at the top portion of ring travel, which increases the ring gap .036". Therefore, it is entirely possible for the ring to have .061" end gap in that portion of the cylinder and be within recommended manufacturing tolerance.

**The Diagram below shows effect of .012" cylinder taper on ring gap in four-inch bore.**

In order to check ring gap, the rings should be placed at the lowest possible part of the cylinder (below ring travel area) as this is the portion of the cylinder that is unworn and which the ring is sized for. Checking ring gap in the worn portion of the cylinder will show a gap increase in direct relation to the amount of cylinder wear present. The illustration below shows the effect of cylinder wear on ring gap.
